NASA TN D-7632

HOLOGRAPHIC AND ULTRASONIC DETECTION OF BOND FLAWS IN ALUMINUM PANELS REINFORCED WITH BORON-EPOXY

by Robert J. Platt, Jr., and Lewis B. Thurston, Jr.

*Langley Research Center
Hampton, Va. 23665*

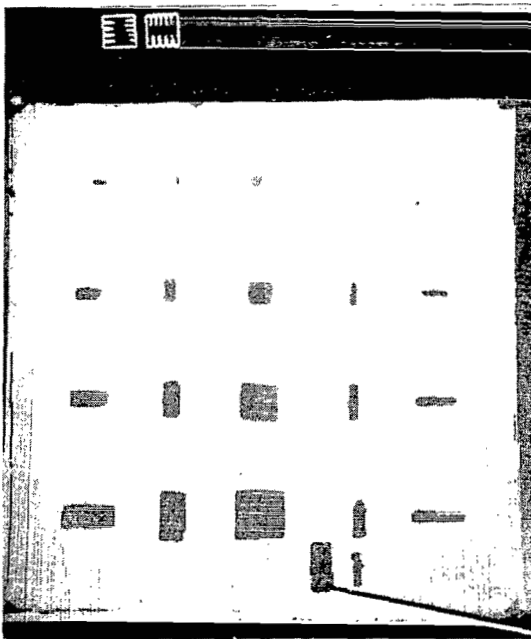
The best results using the auxiliary reflector technique were obtained with the 15-MHz transducer and are shown in figures 6(c) and 6(d). These figures show that equally good results were obtained with the transducer facing either the composite or the metal side. This technique tends to emphasize any area which impedes the transmission of ultrasonic energy more than a well-bonded area of the panel. Thus, a rectangular piezoelectric wafer and metal foil lead, used for vibrating the panel for a holographic test, are clearly visible at the bottom of figures 6(c) and 6(d) and are indistinguishable from the flaws.

(c) Auxiliary reflector technique with 15-MHz focused transducer facing composite side.

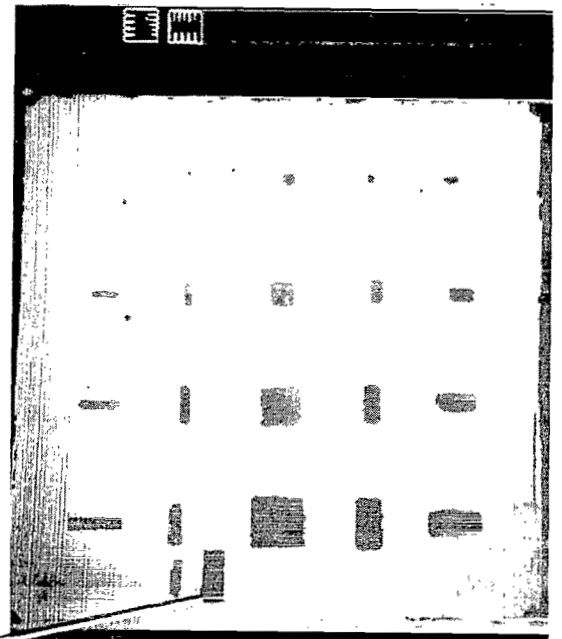
(d) Auxiliary reflector technique with 15-MHz focused transducer facing metal side.

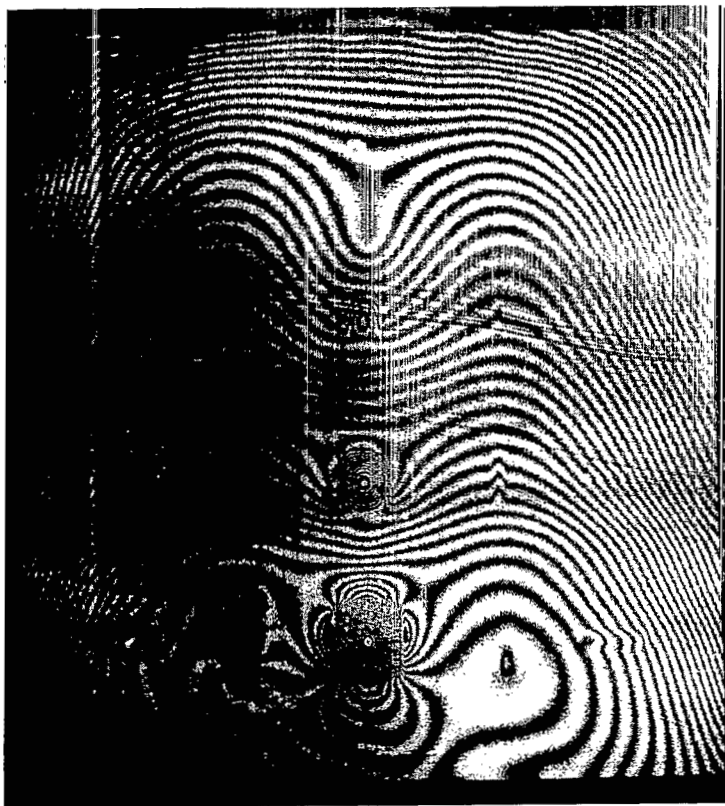
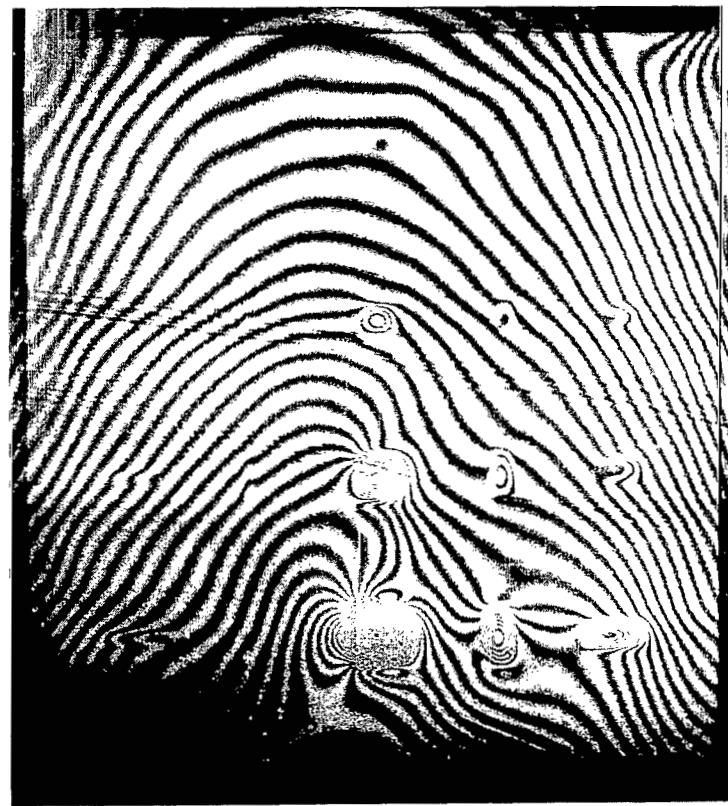
Figure 7.- Results of double-exposure holography of panel A with an ambient pressure decrease of 0.95 atmosphere.

The results of the holographic examination of panel A, by using a bell jar and vacuum pump to decrease the ambient pressure on the panel, are shown in figure 7. It is apparent that this method of panel deformation, used with double-exposure holography, brings out many of the flaws. The relatively small flaw 0.5 cm square, near the top center of each photograph, was detected under five plies of boron-epoxy (fig. 7(a)) and under 0.64 mm of aluminum (fig. 7(b)). In figure 7(a), this flaw shows up as a discontinuity in one of the overall fringe lines, and in figure 7(b), it shows up as a dark dot.

Removal of air in the bell jar created an overall interference fringe pattern on the panel. These fringes are believed to stem mainly from bending of the bell jar base plate and optical path differences which resulted when the air was removed. Some nearly horizontal streaks crossing the pictures were caused by nonhomogeneity of the glass.

Examination of figure 7 shows that the flaw indications give a somewhat distorted impression of the flaw shape. The larger flaws give the illusion of being stretched in the filament direction when viewed from the composite side and stretched perpendicular to the filament direction when viewed from the metal side. These effects are believed to stem from the fact that the stiffness of the composite sheet in the filament direction is greater than the aluminum sheet, and the stiffness perpendicular to the filament direction is less than the aluminum.

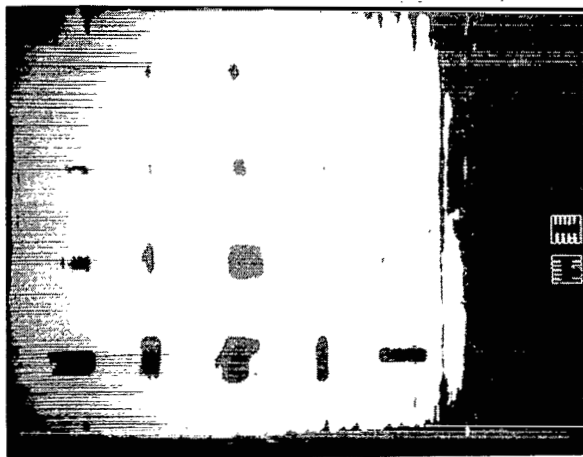
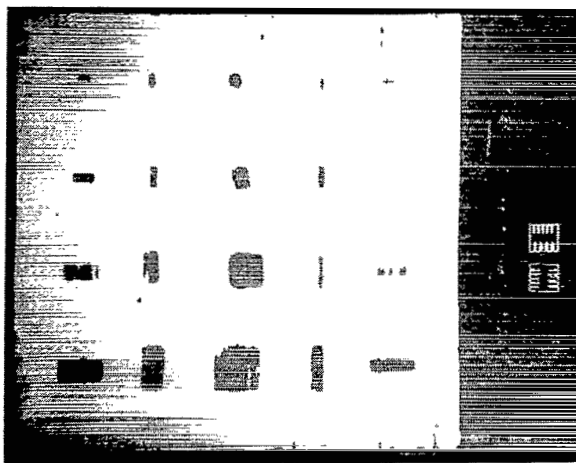
Figure 10.- Results of ultrasonic inspection of panel B.

Ultrasonic inspection.- Figure 10 presents the best results obtained with the ultrasonic flaw-detection equipment. By using the pulse-echo technique, better delineation of the flaws was obtained from the metal side (fig. 10(b)) than from the composite side (fig. 10(a)). As in the case of panel A, this is believed to be due to the greater attenuation and scattering of ultrasound in passing through the boron-epoxy composite as compared to the more homogeneous metal. Results by using the auxiliary reflector technique (fig. 10(c)) were almost as good as the pulse-echo results from the metal side. One of the smaller intended flaws did not show up and was apparently bonded to the metal. Compared to the results of the ultrasonic inspection of panel A (fig. 6), the increased thickness of panel B had little effect on detectability of the flaws, since even the smallest was detected.

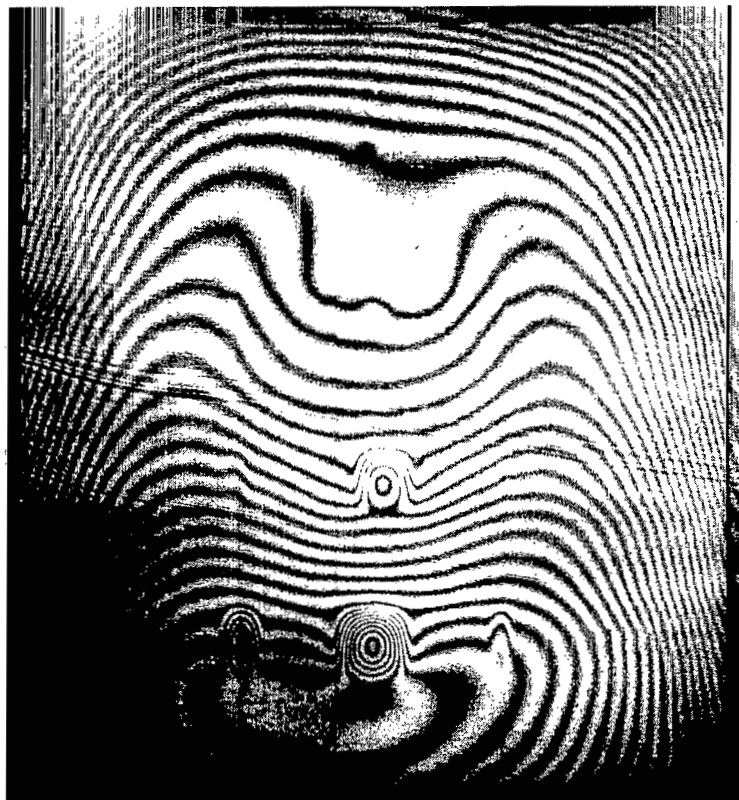
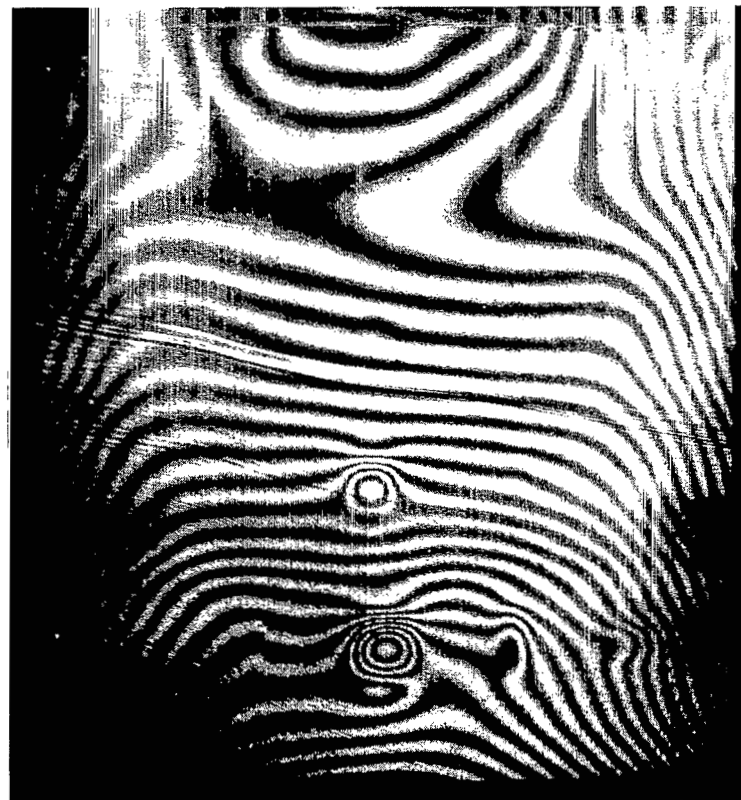
Figure 11.- Results of double-exposure holography of panel B with an ambient pressure decrease of 0.95 atmosphere.

Holographic inspection.- Only the vacuum chamber method of panel deformation was used for panel B. These results are shown in figure 11. The increased thickness of panel B, of course, resulted in much lower sensitivity of flaw detection than in the case of panel A (fig. 7). However, the sensitivity was sufficient to detect a 1-cm-square flaw beneath 10 plies of boron-epoxy. This flaw is located slightly above the center of the panel shown in figure 11.

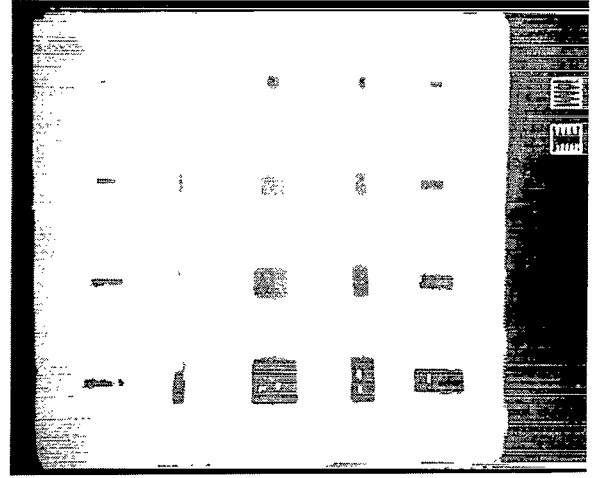
Ultrasonic inspection.- The results obtained with the pulse-echo technique are shown in figure 12(a). Four of the smallest flaws were not detected and the larger flaws were not well defined. Much better results were obtained using the glass reflector (fig. 12(b)). One of the larger intended flaws was barely visible and is believed to be almost completely bonded.

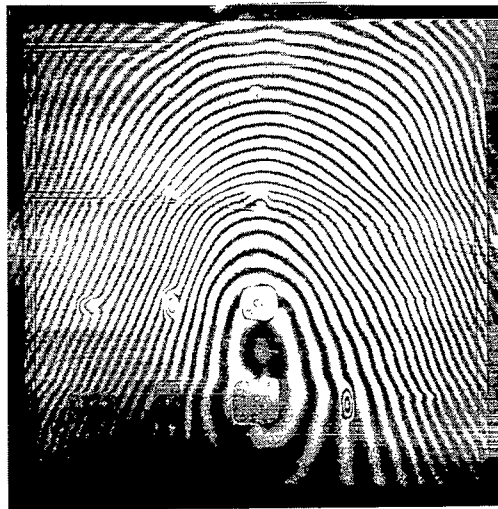
Holographic inspection.- The holography results obtained with vacuum chamber deformation of panel C are shown in figure 12(c). This photograph views the panel from the side opposite that used for the ultrasonic tests. The sensitivity of flaw detection was about the same as for panel A, but without the apparent flaw shape distortions found with panel A. As with panel A, a 0.5-cm-square flaw was detected beneath five plies of boron-epoxy.

(c) Ambient pressure decrease of 0.95 atmosphere. Painted side shown.

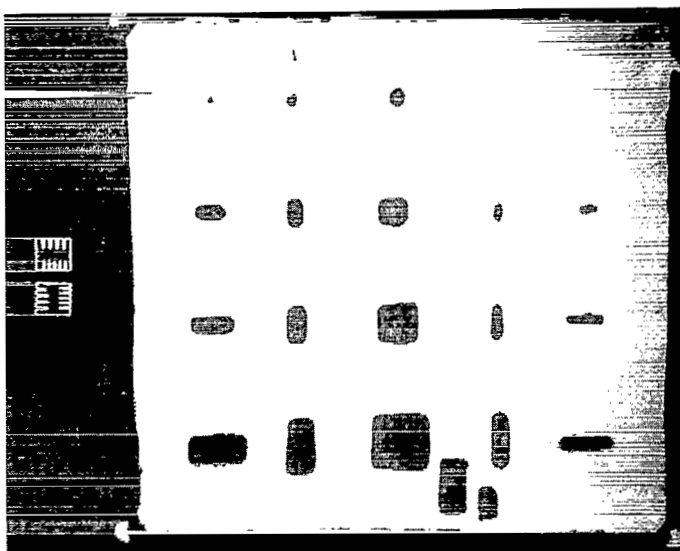
Figure 13.- Results of ultrasonic inspection of panel D.

Ultrasonic inspection.- The results obtained using the pulse-echo technique are shown in figure 13. From the composite side, the two smallest flaws could not be detected (fig. 13(a)). From the metal side, all the flaws were detected (fig. 13(b)) and the flaw shapes were better defined than from the composite side.

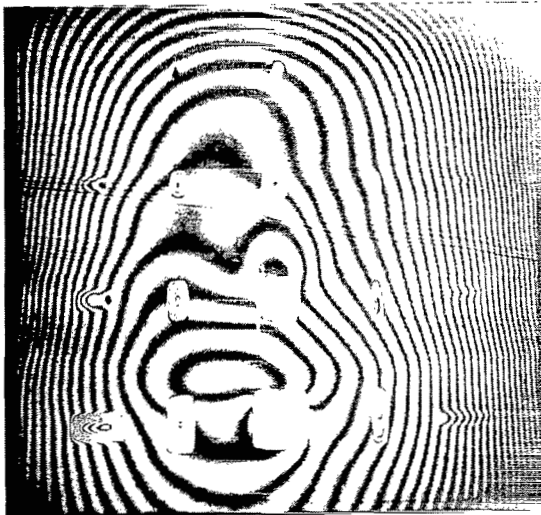
Holographic inspection.- The results obtained with an ambient pressure reduction by means of the bell jar are shown in figure 14(a). The view is from the composite side. All but three of the smallest flaws may be detected in this hologram. The shapes of the larger flaws are well defined except for some rounding of the corners. The apparent distortion of the unbonded areas noted for panel A (fig. 7) was not present for panel D, which had the thicker aluminum.

(a) Ambient pressure decrease of 0.98 atmosphere.

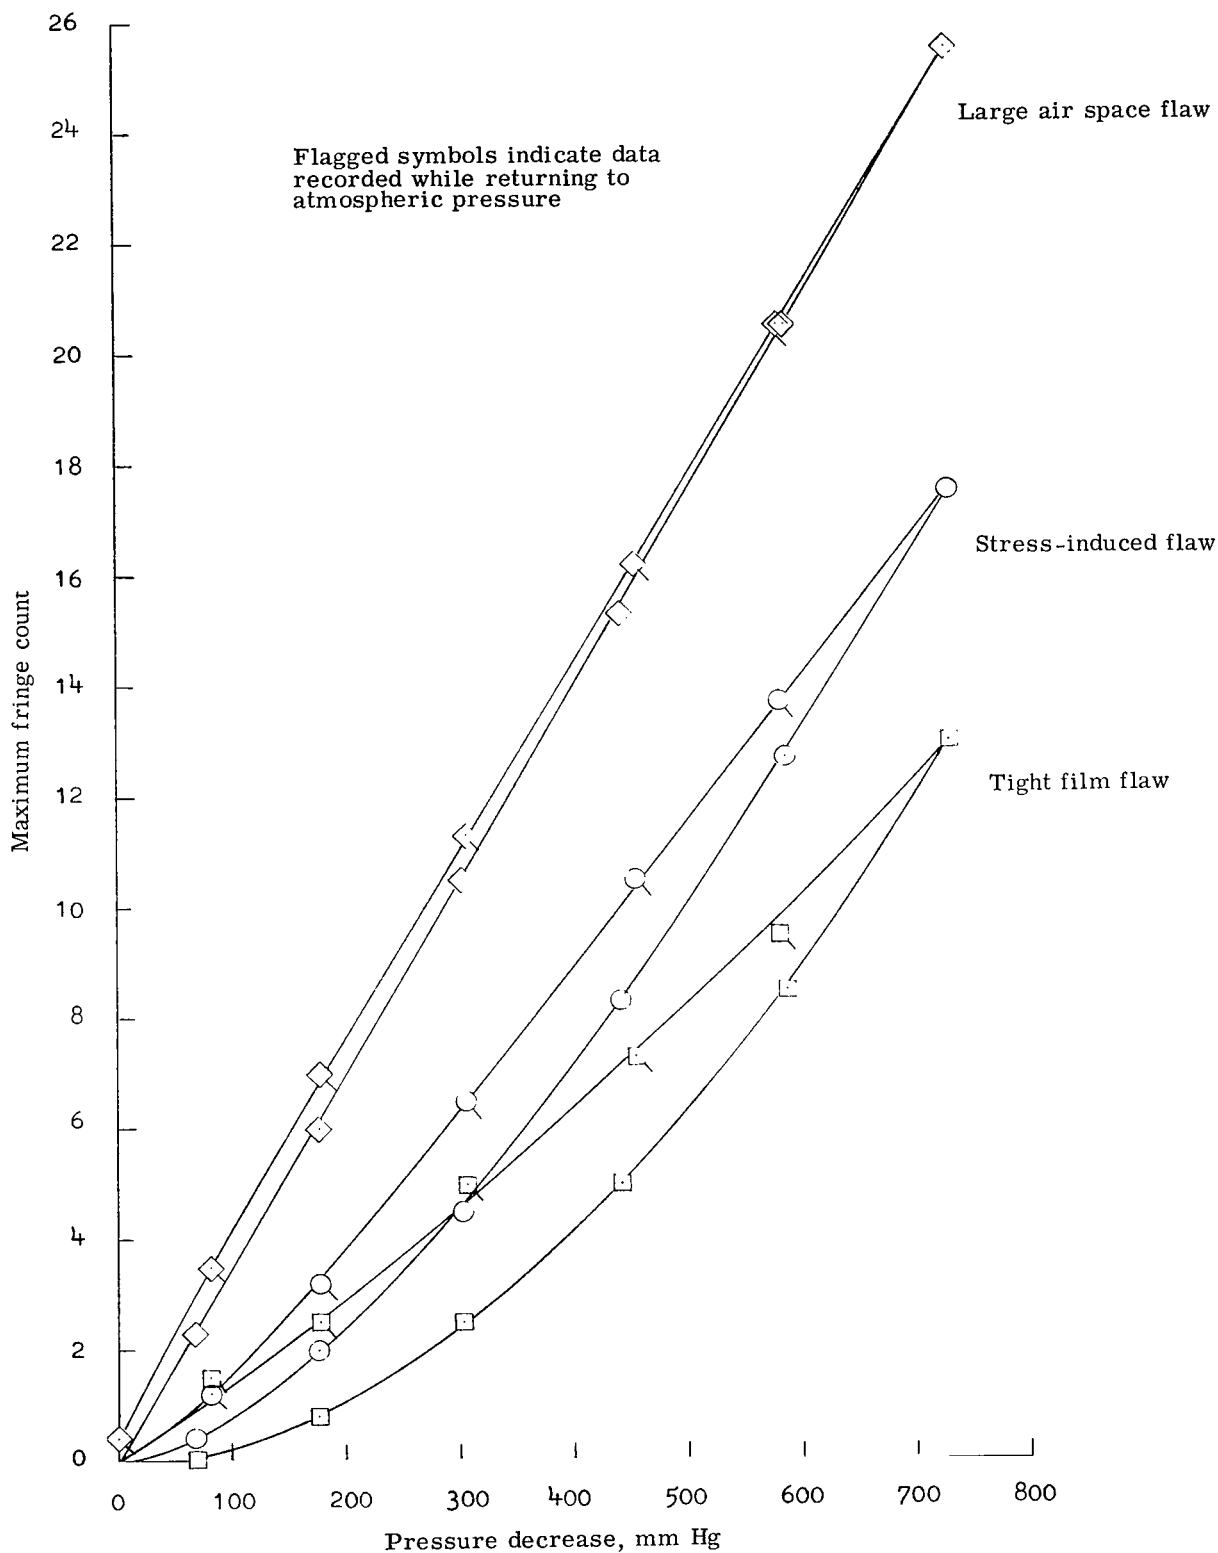
Figure 17.- Sensitivity of unbonded areas of different manufacture to a decrease in ambient pressure below atmospheric pressure. Holographic interferometry was used.

These fringe counts were made for the three samples at several vacuum conditions and are plotted in figure 17. Displacement of the surface varies directly with the fringe count. Fringes were recorded as the pressure was decreased and again as the pressure was returned to atmospheric. Some hysteresis effect is evident in these curves in spite of a wait of several minutes at each pressure before the fringes were recorded. Figure 17 shows that the flaw with the large air space deflected the most and the tight film flaw, made by the same method as was used for the four test panels, deflected the least and showed more evidence of hysteresis. The stress-induced flaw curve, with no trapped air, fell between the other two.

The behavior of these flaw specimens indicates that airtight stress-induced flaws, such as service-induced internal failure, may be detected with holography by using an ambient pressure decrease. Inclusion of gas in the flaw is not required for the method to work, since adhesive failure results in a slight separation of the previously bonded surfaces.
